River Liffey WFD III Barrier Assessment Obstacles to Fish Passage and Mitigation Options

IFI/2023/1-4635

Citation: Donovan, R., Coghlan, B., O’Brian, R., & O’Leary, C., (2022). River Liffey WFD 111 Barrier Assessment – Obstacles to Fish Passage and Mitigation Options. National Barriers Programme. Inland Fisheries Ireland. Citywest, Dublin.

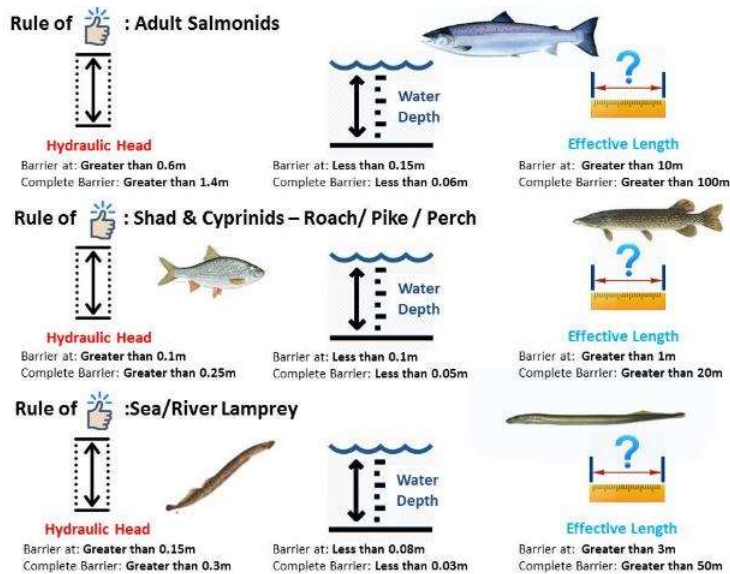
Figure 1. Guideline metrics for assessing barrier risk.

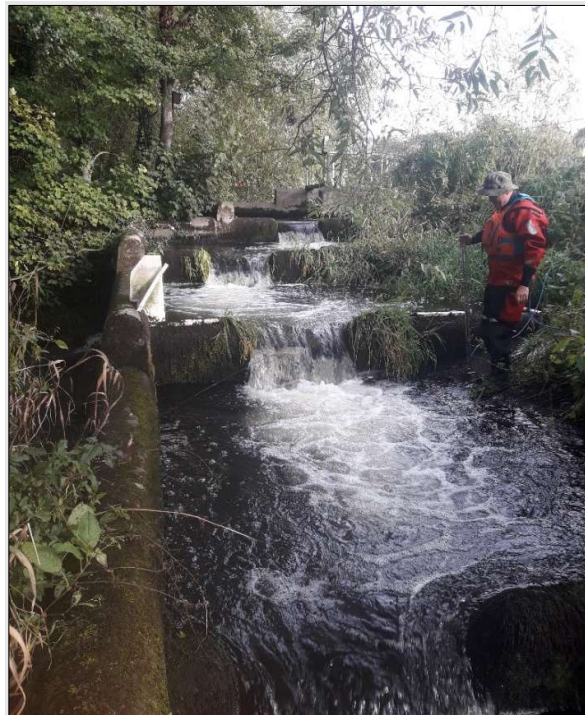
In prevailing conditions, this fish passage option was a complete barrier (score 0.0) to upstream migration for all species except adult salmonids and juvenile eel. The box step height of 0.47m presented a jump barrier to cyprinids, adult lamprey, and juvenile salmonids. The low step water depth (0.65m) created a high impact partial barrier for adult salmonids (score 0.3). However, this transversal did offer a climbing substrate to juvenile eel, allowing the species complete passability (score 1.0). High flows have the potential to improve passage for adult salmonids due to increased depths. Sufficient water depths and low velocities at the crest, in addition to a lack of damaging structures or debris, mean downstream migrants faced no barrier (score 1.0) at this fish passage option.

Figure 7. Fish passage option (TS1).

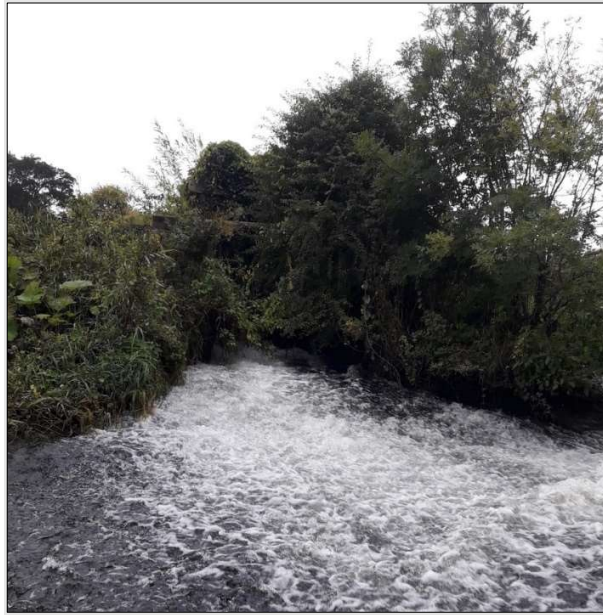
In prevailing conditions, this sluice was a complete barrier (score 0.0) to upstream migration for all fish. High levels of turbulence created a swim barrier for cyprinids, adult lamprey, juvenile eel, and juvenile salmonids. High velocities at the midpoint and crest (1.01m/s to 3.4m/s) represented an additional swim barrier for non-salmonids. The slope (10.71%), lack of effective resting locations, and high levels of turbulence created a high impact partial barrier (score 0.3) for adult salmonids. With regard to downstream migration, adult trout, juvenile lamprey, and adult eel faced no barrier (score 1.0). However, velocities greater than 1.65m/s at the crest impeded the downstream migration of cyprinids (score 0.3) and both juvenile and adult salmon (score 0.6).

Figure 8. Sluice (TS2).

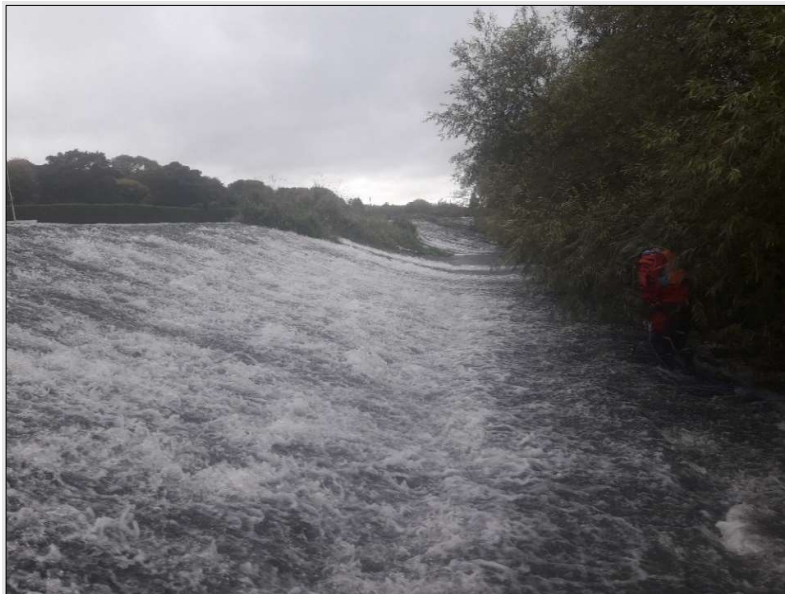
In prevailing conditions, the weir face was a complete barrier (score 0.0) to upstream migration for all species except juvenile eel. The slope (25.32%), high turbulence, and low depths at the midpoint and crest all presented obstacles. Juvenile eel could surmount this transversal utilising the climbing substrate available. Therefore, the structure was no barrier (score 1.0) to their upstream passage. With regard to downstream migration, juvenile salmonids, juvenile lamprey, and adult eel faced no barrier (score 1.0). However, low depths at the weir crest impeded the downstream migration of adult salmon (score 0.3), adult trout (score 0.6), and cyprinids (score 0.6).

Figure 9. Sloping weir face (TS3).

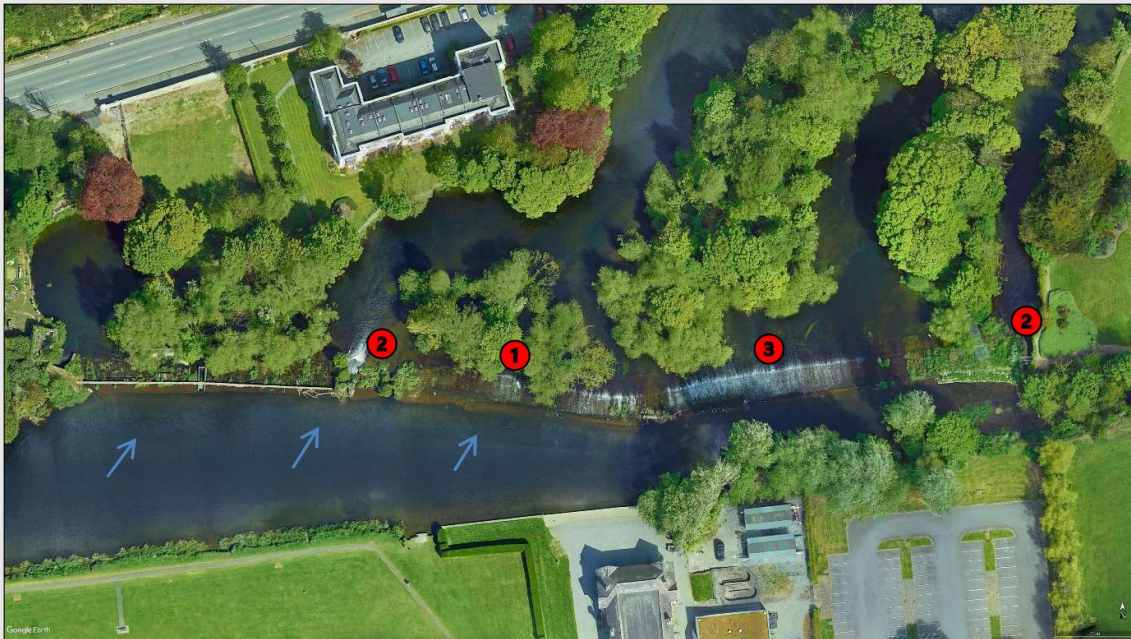
On the day of the survey, Island Bridge Weir represented a complete barrier (score 0.0) for the upstream migration of all species except adult salmonids and juvenile eel (Table 2). Adult salmonids could make passage at transversals one or two, however both were high impact partial barriers (score 0.3). The structure presented no barrier (score 1.0) to juvenile eel, as the species could make passage utilising the available climbing substrate at transversals one or three. With regard to downstream migration, transversal one was the best option, presenting no barrier (score 1.0) to any species. Transversal one also offered the best passability overall, despite not facilitating the upstream passage of cyprinids, adult lamprey, or juvenile salmonids. High flows will improve the structure, reducing it to a low impact partial barrier (score 0.6) for adult salmonids. However, for cyprinids, adult lamprey, and juvenile salmonids migrating upstream, it will remain impassable.

Figure 10. Google Earth ortho-imagery of Island Bridge Weir, April 2020. Blue arrows denote flow direction and red circles indicate transversal section number.

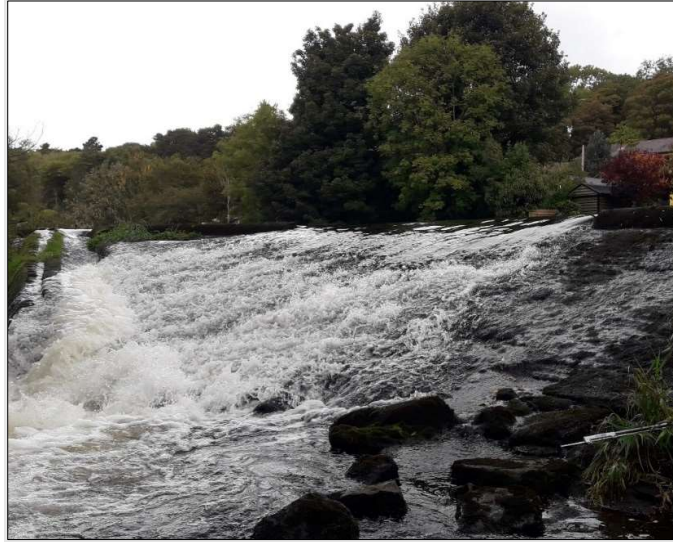
In prevailing conditions, this transversal was a complete barrier (score 0.0) to upstream migration for all species except adult trout and juvenile eel. The slope (27.22%) and high levels of turbulence at this transversal represented a complete barrier for cyprinids, adult lamprey, and juvenile salmonids. Meanwhile, the low depths ($\leq 0.07\text{m}$) at the midpoint and outlet created a complete barrier for adult salmon passage. High flows will improve this transversal, reducing it to a high impact partial barrier (score 0.3) for adult salmon, due to increased depths. The low water depths on the face of the weir also presented an issue for adult trout, however not to the same extent. Due to the slope, limited depths, standing wave, and turbulence, this transversal was a high impact partial barrier (score 0.3) for adult trout. Juvenile eels faced no barrier and could make passage on the available climbing substrate. In a downstream direction, the transversal was passable for migrants of all species (score 1.0).

Figure 13. Breach into TS1 by TS2.

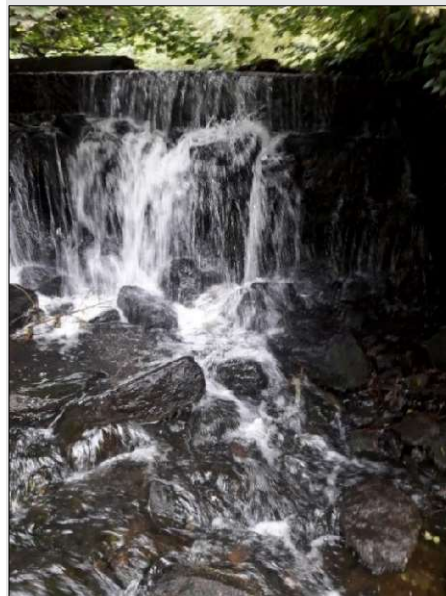
In prevailing conditions, this transversal was a complete barrier (score 0.0) to upstream migration for all species except juvenile eel. The hydraulic head or vertical drop height, at 1.96m, posed a complete jump barrier. The low water depths at the weir crest ($\leq 0.05\text{m}$) and launching (plunge) pool (0.12m) were additional complete barriers for adult salmonids. Juvenile eel could make passage on the available climbing substrate. The limited crest depths also created a complete barrier for the downstream migration of adult salmonids and cyprinids. The rocky outcrop and boulders at the outlet of the transversal had the potential to harm downstream migrants. These damaging structures represented a high impact partial barrier (score 0.3) for the species (juvenile salmonids, juvenile lamprey, and adult eel) able to overcome the low crest depths.

Figure 14. Vertical drop (TS3).

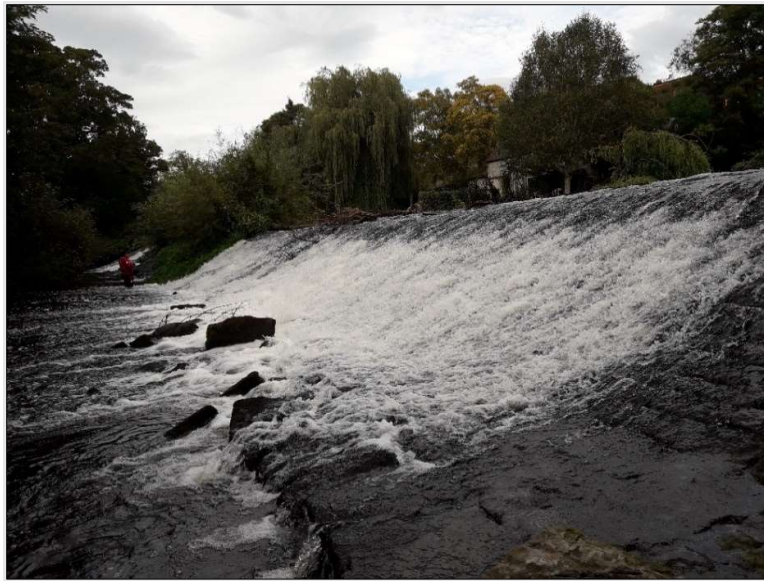
In prevailing conditions, the weir face was a complete barrier (score 0.0) to upstream migration for all species except juvenile eel. The slope (41.70%) and high levels of turbulence were the primary factors limiting upstream passage. The low water depths ($\leq 0.07\text{m}$) at the midpoint and crest were an additional complete barrier for adult salmon. Juvenile eel could use the available climbing substrate along the edge of the transversal to make passage. Downstream migration was impeded completely (score 0.0) for adult salmon due to low water levels at the weir crest. Cyprinids and adult trout were also impacted, with the low depths creating a high impact partial barrier (score 0.3) for downstream passage.

Figure 15. Weir face (TS4).

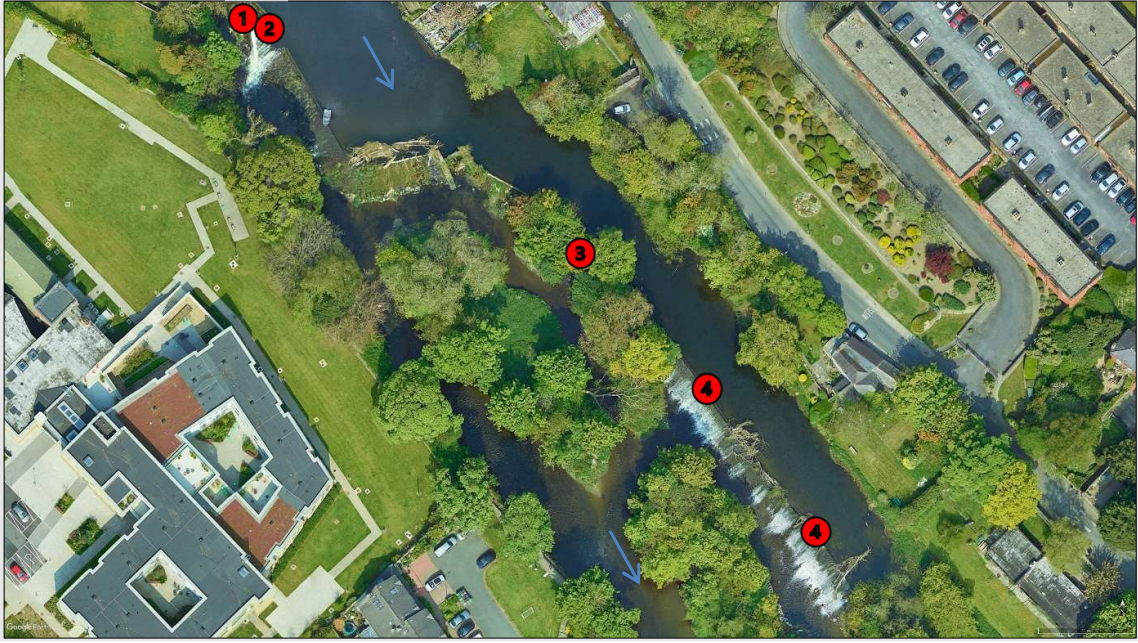
On the day of the survey, Chapelizod Weir represented a complete barrier (score 0.0) to upstream migration for all species except adult salmonids and juvenile eel (Table 3). Different routes were better suited to different species. Both transversals one and two offered passage to adult trout. However, only transversal one presented a viable passage option for adult salmon. The transversals suitable for adult salmonid passage were high impact partial barriers (score 0.3), allowing restricted passability. The structure presented no barrier (score 1.0) to juvenile eel, as the species could make passage utilising the available climbing substrates at transversals two, three, or four. Turbulence and slope were the common issues amongst transversals one, two, and four. However, the vertical drop was the major limiting factor at transversal three. Downstream migration for all species was best catered for at transversals one and two.

Figure 16. Google Earth ortho-image of Chapelizod Weir, April 2020. Blue arrows denote flow direction and red circles indicate transversal section number.

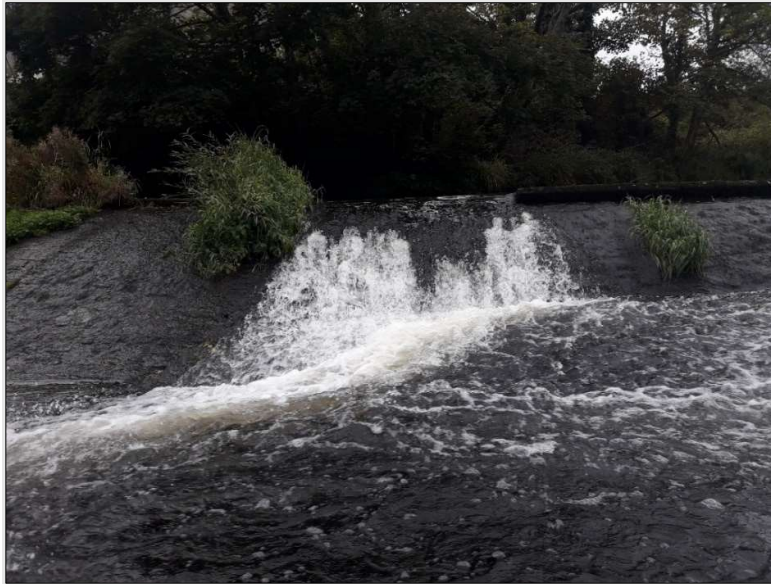
In prevailing conditions, this transversal was a complete barrier (score 0.0) to the upstream migration of all species except adult salmonids and juvenile eel. Multiple factors contributed to the negative impact on upstream passage. The slope (26.29%) and high levels of turbulence were complete barriers for cyprinids, adult lamprey and juvenile salmonids. High velocities (1.7m/s to 3.5m/s) at the outlet and midpoint created an additional swim barrier for cyprinids and adult lamprey. The same high velocities, combined with low depths (0.07m to 0.12m), rendered the transversal a high impact partial barrier (score 0.3) for adult salmonids. The slope, lack of effective resting locations and high turbulence also restricted the passage of adult salmonids. Juvenile eel could avail of the climbing substrate to surmount the transversal and therefore experienced no

barrier (score 1.0). There was also no barrier (score 1.0) to downstream migration for any species at this segment of the weir face.

Figure 18. Weir face without crest lip (TS1).

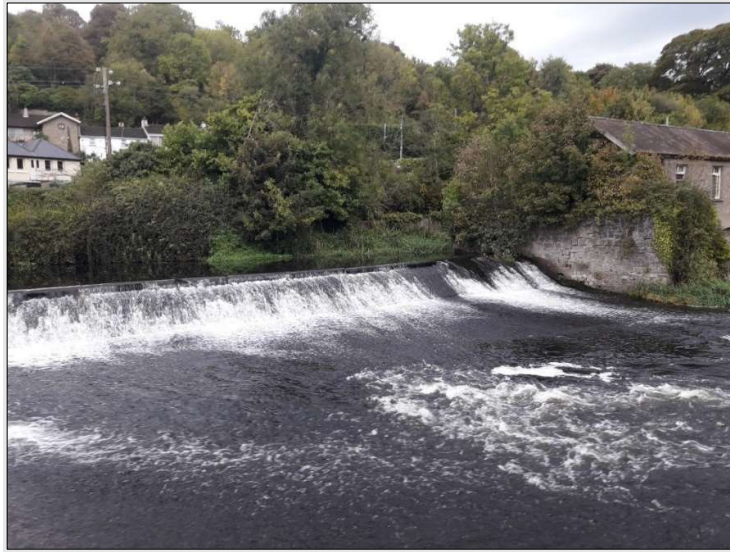
In prevailing conditions, this transversal was a complete barrier (score 0.0) to the upstream migration of all species except adult trout. High levels of turbulence presented a complete swim barrier for cyprinids, adult lamprey, juvenile eel, and juvenile salmonids. Additionally, the slope (26.29%) of the weir face was a complete barrier for cyprinids, adult lamprey, and juvenile eel. Low depths at the midpoint (0.04m to 0.07m) created a complete barrier (score 0.0) for adult salmon. The low depths, in addition to the slope, turbulence, lack of effective resting locations, and lip at the weir crest constituted a high impact partial barrier (score 0.3) for adult trout. Downstream migration was unhindered for almost all species. Only adult salmon were restricted by the low depths at the weir crest (0.06m to 0.12m), which formed a low impact partial barrier (score 0.6) for the remaining species. Elevated flows will improve the passability at this transversal for adult salmon migrating both upstream and downstream.

Figure 19. Weir face with crest lip (TS2).

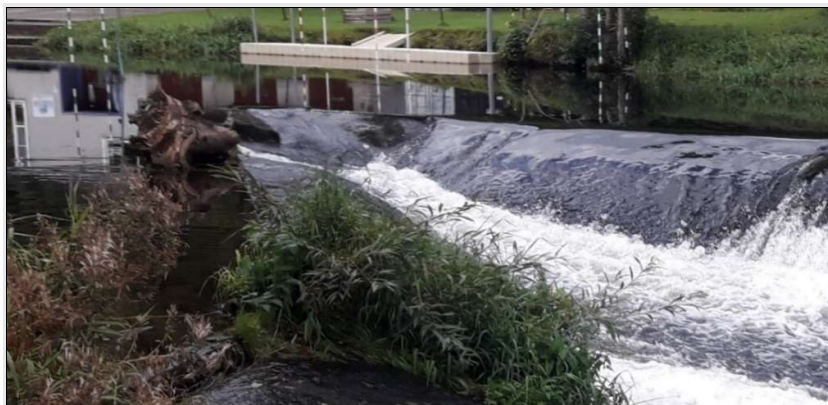
In prevailing conditions, this fish passage option was a complete barrier (score 0.0) to the upstream migration of all species. In a continuing trend for this weir, turbulence was a major obstructing factor. This transversal was a complete barrier (score 0.0) for cyprinids, adult lamprey, juvenile eel, and juvenile salmonids due to high levels of turbulence. Low depths (0.04m to 0.05m) at the transversal's midpoint created a complete barrier (score 0.0) for all species except juvenile salmonids. The cumulative impact of the depth and swim barriers meant that this transversal was not a functional fish passage option for any species migrating upstream on the day of survey. In high flows, due to increased depth, the transversal will lessen to a high impact partial barrier for adult salmonids. There was no barrier (score 1.0) to downstream migration for any species.

Figure 20. Fish passage option (TS3).

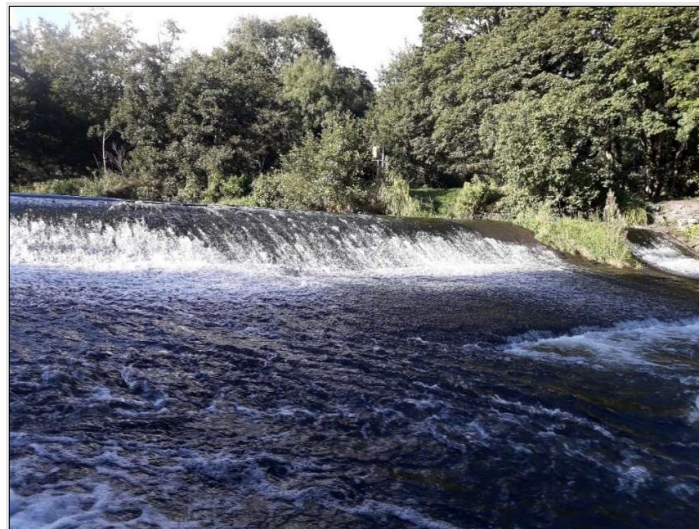
In prevailing conditions, this transversal was a complete barrier (score 0.0) to the upstream migration of adult salmonids and cyprinids. Low water depths (0.03m to 0.05m) at the outlet and midpoint of the weir face entirely restricted passage for these species. The limited depths also impacted adult lamprey and juvenile salmonids, creating a high impact partial barrier (score 0.3). Medium levels of turbulence, effective length (9.3m), slope (15.59%), and the presence of a lip at the weir foot were additional high impact partial barriers (score 0.3) for adult lamprey, juvenile salmonids, and cyprinids. Juvenile eel encountered no barrier (score 1.0), as the species could employ the available climbing substrate to surmount the weir face. Downstream migration was unhindered for all species except adult salmon. Low depths at the transversal crest presented a low impact partial barrier (score 0.6) for the species travelling in a downstream direction. High flows will improve the transversal to a high impact partial barrier (score 0.3) for the upstream migration of adult salmonids and cyprinids. The passability of this segment of the weir for downstream migrating adult salmon will also be improved.

Figure 22. Weir face (TS1).

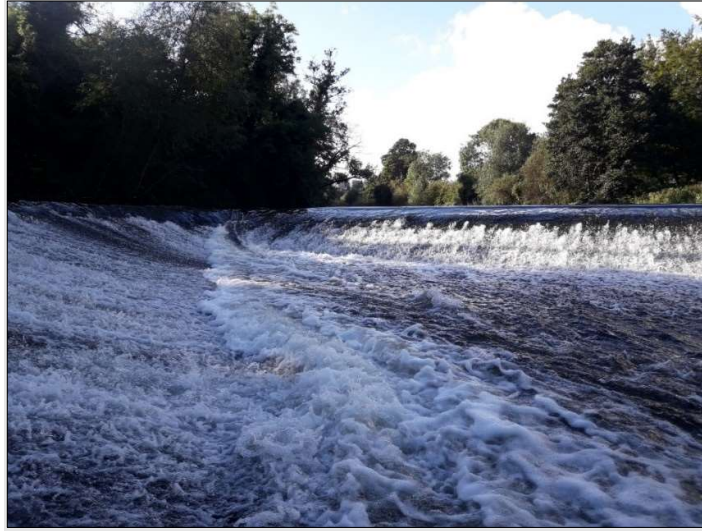
In prevailing conditions, this transversal was a complete barrier (score 0.0) to the upstream migration of all species except adult salmonids. High levels of turbulence and high velocities (2.14m/s to 3.21m/s) at the outlet created a complete swim barrier for cyprinids, adult lamprey, juvenile eel, and juvenile salmonids. The transversal was rendered a high impact partial barrier (score 0.3) for adult salmonids due to the slope (11.07%) and turbulence. Conditions at the transversal's crest created a swim/depth barrier for cyprinids, juvenile salmonids, and adult salmon migrating downstream. High velocities (1.85m/s to 2.12m/s) impinged on the downstream passage of cyprinids (score 0.3) and juvenile salmonids (score 0.6). Meanwhile, lower water depths (0.1m to 0.11m) established a low impact partial barrier (score 0.6) for downstream migrating adult salmon.

Figure 23. Slope (TS2).

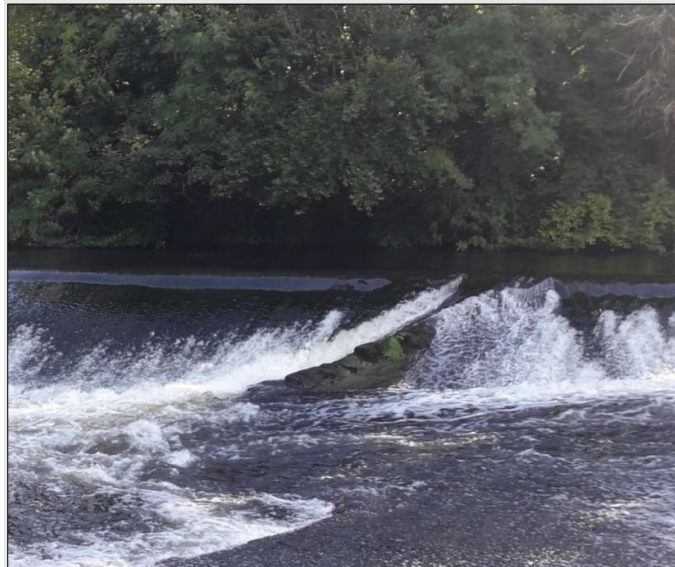
In prevailing conditions, this fish passage option was a complete barrier (score 0.0) to the upstream migration of all species. Elevated velocities at the midpoint and outlet (3.98m/s to 4.8m/s) created an insurmountable swim obstacle. High levels of turbulence were an additional swim barrier for cyprinids, adult lamprey, juvenile eel, and juvenile salmonids. Lesser velocities at the transversal crest (0.92m/s to 1.06m/s) meant fish travelling downstream encountered no barrier (score 1.0).

Figure 24. Fish passage option (TS3).

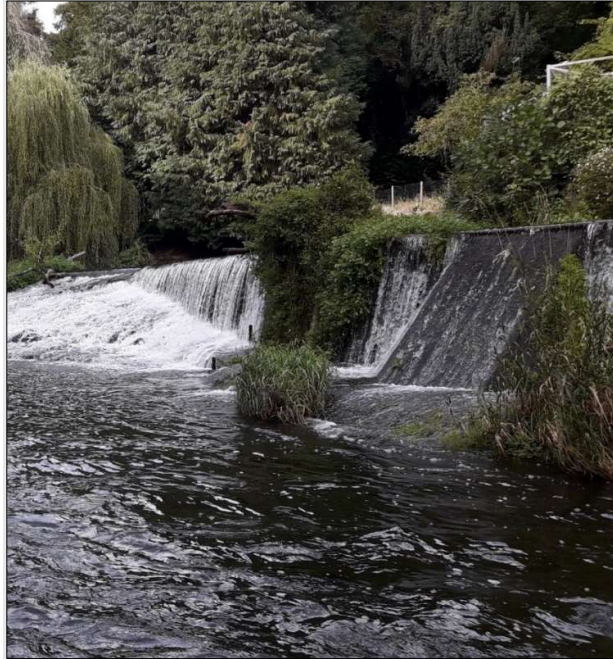
In prevailing conditions, this vertical drop was a complete barrier (score 0.0) to the upstream migration of all species. The hydraulic head (1.86m) and lack of effective pool depth (0.03m) was a complete barrier to adult salmonids. Meanwhile, high levels of turbulence constituted a complete swim barrier for cyprinids, adult lamprey, juvenile eel, and juvenile salmonids. Downstream migrants were hindered by an exposed rocky sill which could injure individuals attempting to employ this transversal. The presence of a physically damaging element to this structure rendered this transversal a high impact partial barrier (score 0.3) for all species migrating downstream.

Figure 27. Vertical drop (TS1).

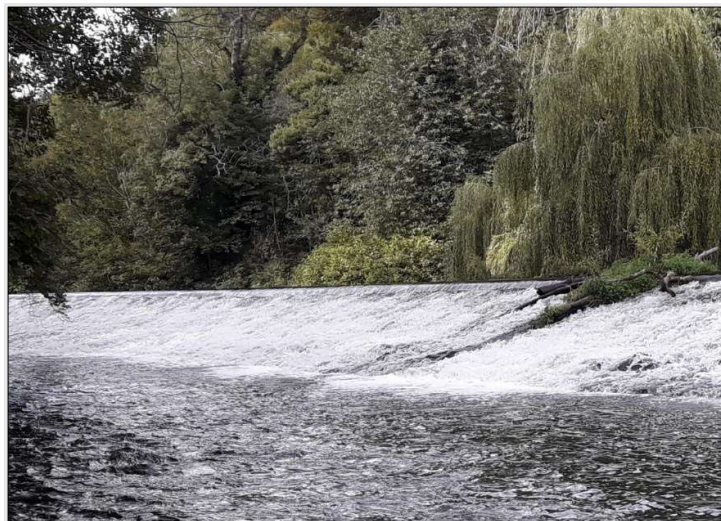
In prevailing conditions, this transversal was a complete barrier (score 0.0) to the upstream migration of all species except juvenile eel. The slope (29.06%) and high levels of turbulence were complete barriers for cyprinids, adult lamprey, and juvenile salmonids. Adult salmonids encountered a complete depth barrier (water depth $\leq 0.05\text{m}$) at the outlet of this section of the weir face. The upstream migration of adult salmonids will be aided by increased depths during high flows. However, additional obstructing factors such as high turbulence will ensure that the structure does not improve beyond a high impact partial barrier (score 0.3). Juvenile eel were presented with no barrier (score 1.0) due to the available climbing substrate.

Figure 28. Weir face (TS2).

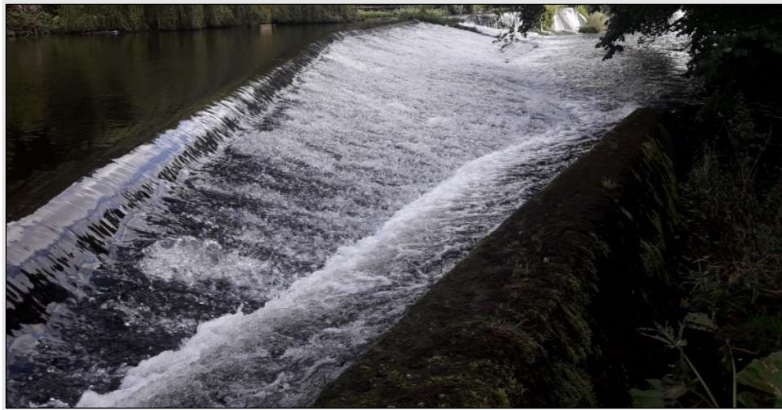
In prevailing conditions, this fish passage option was a high impact partial barrier (score 0.3) to all salmonids. The slope (11.34 %) and crest lip were common factors negating passage. For cyprinids and adult lamprey, the transversal was as a complete barrier (score 0.0). High velocities at the outlet and midpoint (2.39m/s to 4.02m/s) created an effective swim obstacle for these species. For juvenile eel, a climbing substrate was available and therefore no barrier (score 0.0) encountered. Downstream migrants of all species faced no barrier (score 0.0) at this fish passage option.

Figure 29. Fish passage option (TS3).

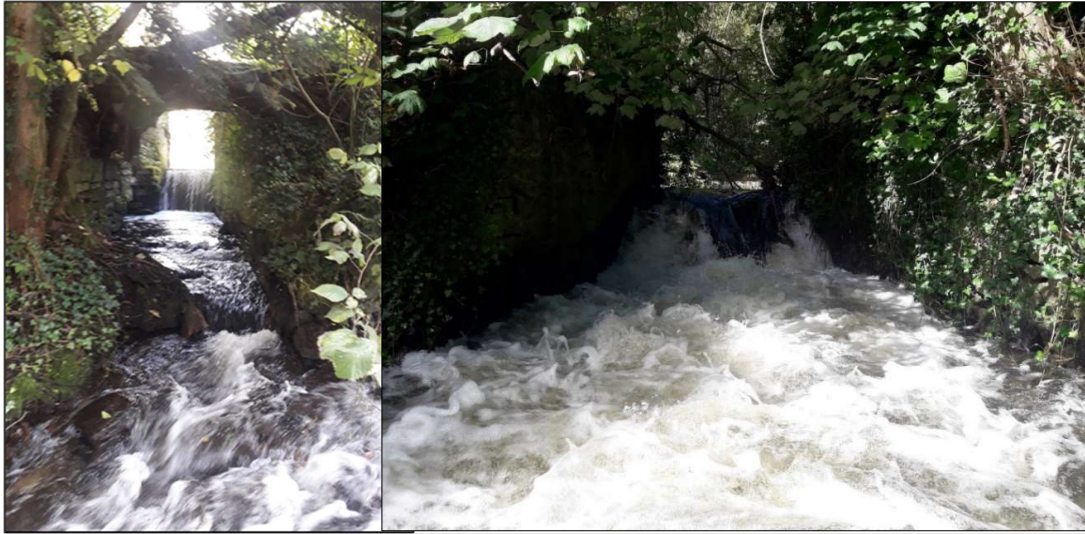
In prevailing conditions, this sluice was a complete barrier (score 0.0) to the upstream migration of all species except adult trout and juvenile eel. Adult salmon were impeded by low depths ($\leq 0.06\text{m}$) at the crest, while cyprinids, adult lamprey, and juvenile salmonids were unable to surmount the vertical hydraulic head (0.92m). For adult trout's upstream passage, the low crest water depths, hydraulic head, and effective pool depth (0.41m) generated a high impact partial barrier (score 0.3). The transversal was also a high impact partial barrier for juvenile eel due to medium levels of turbulence. All species travelling downstream, excluding juvenile lamprey, were impacted to varying degrees by limited depths at the transversal crest. High flows will render this transversal a viable route for adult salmon migrating upstream, in addition to improving the downstream passage for all species.

Due to unsafe conditions on the day of survey, there were no depth or velocity measurements taken at this sluice. However, the combination of high levels of turbulence, a low effective pool depth (0.25m), and the vertical hydraulic head (1m) rendered this transversal a complete barrier (score 0.0) to upstream migration for all species in prevailing conditions. Structures damaging to downstream migrants were present, creating a high impact partial barrier (score 0.3) for all species travelling in that direction.

Figure 30. Sluices at Anna Liffey Weir.

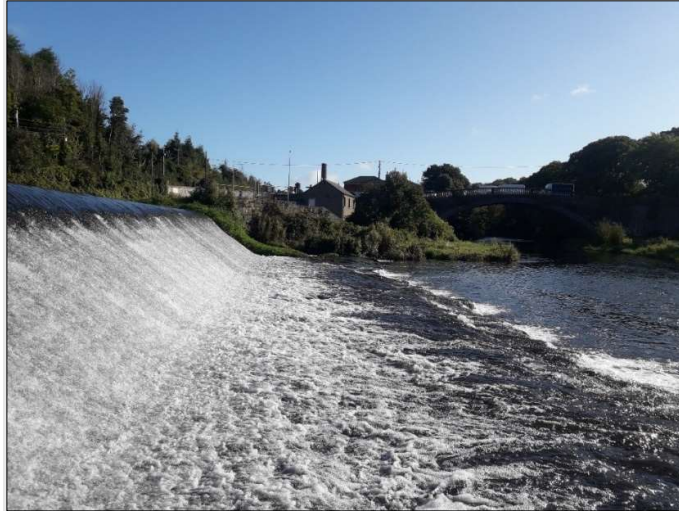
In prevailing conditions, this transversal was a complete barrier (score 0.0) to the upstream migration of all species. Slope (22.42%) was a common prohibitive factor. However, additional swim and depth barriers compounded this impact. High levels of turbulence created a complete swim barrier for cyprinids, adult lamprey, juvenile eel, and juvenile salmonids. Low depths ($\leq 0.03\text{m}$) at the midpoint of the weir were a complete depth barrier to all species except juvenile eel. For juvenile eel, it was the midpoint velocities (1.28m/s to 2.75m/s) that were an additional obstruction to passage. Downstream migration was hampered by varying degrees for all species by the low depths ($\leq 0.07\text{m}$) at the crest of the transversal. Adult salmon contended with a complete barrier (score 0.0), while for adult trout and cyprinids the low depths resulted in a high impact partial barrier

Figure 33. Weir face with rock sill (TS1).

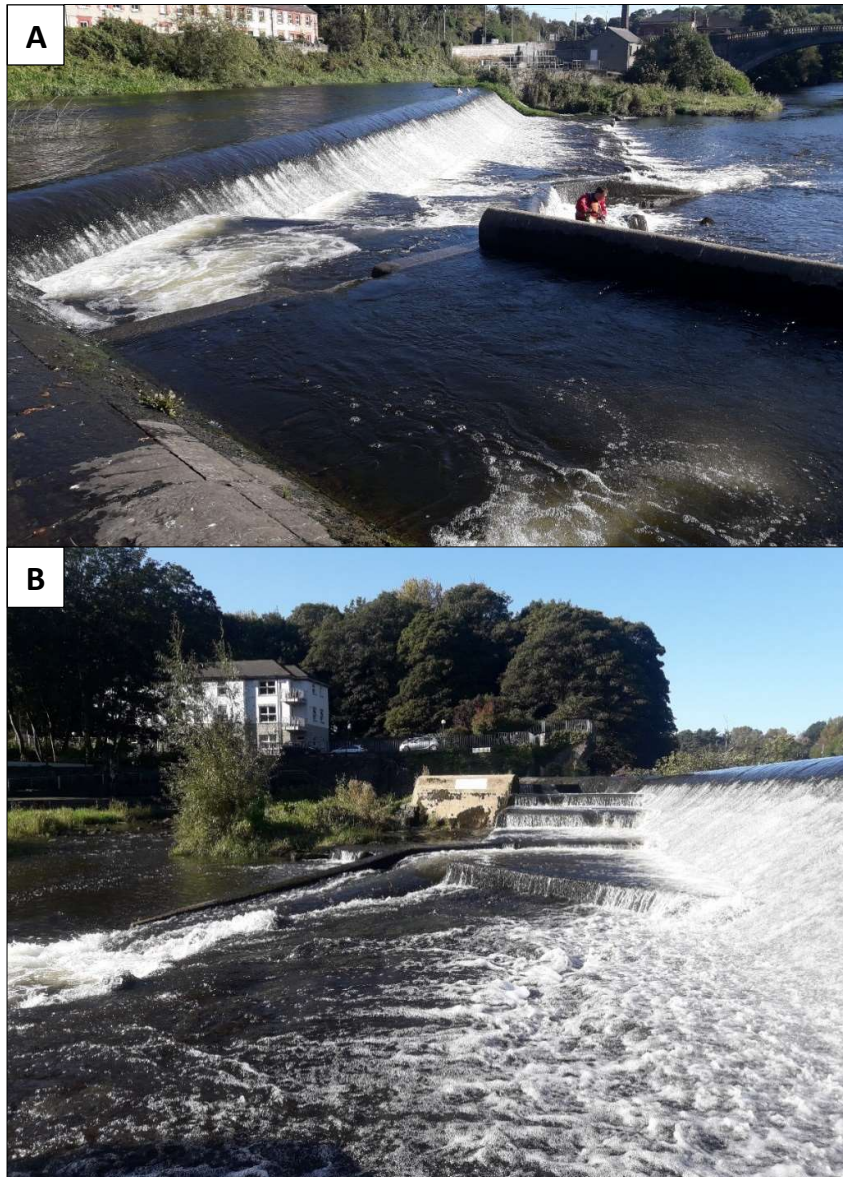
In prevailing conditions, this fish passage option was a complete barrier (score 0.0) to the upstream migration of all species except juvenile eel. For juvenile eel, the available climbing substrate provided a navigable route that resulted in no barrier (score 1.0). For other species, a combination of slope and step features created a range of swim and jump barriers. The slope (52.75%) formed a complete barrier for all species other than juvenile eel. High levels of turbulence and the step height (0.42m) were additional complete barriers for cyprinids, adult lamprey, and juvenile salmonids. High outlet velocities (2.39m/s to 3.11m/s) were yet another complete barrier faced by cyprinids and adult lamprey. Regarding downstream migration, only cyprinids encountered an obstruction. Velocities of 1.49m/s to 1.62m/s created a low impact partial barrier (score 0.6) for the species.

Figure 34. Fish passage option (TS2) from (A) upstream and (B) downstream.

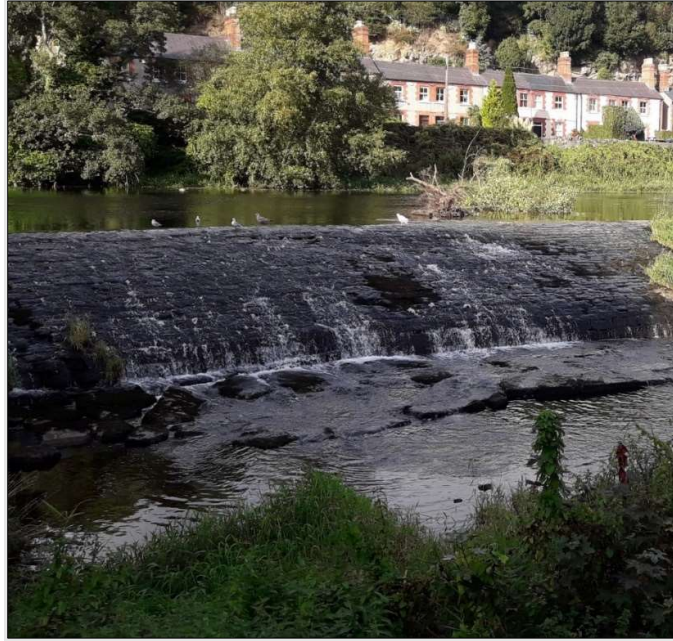
In prevailing conditions, this transversal was a complete barrier (score 0.0) to the upstream migration of all species, except juvenile eel. For juvenile eel, a climbing substrate was available and rendered the transversal no barrier (score 1.0). Low depths ($\leq 0.04\text{m}$) at the midpoint and outlet created a complete barrier for all other species attempting to traverse this section of the weir face. Slope (32.02%) was an additional complete barrier for cyprinids, adult lamprey, and juvenile salmonids. With regards to downstream migration, sufficient water depths and low velocities (0.1m/s to 0.42m/s) at the crest, combined with a lack of debris or damaging structures, ensured that this transversal presented no barrier (score 1.0) to any species.

Figure 35. Weir face (TS3).

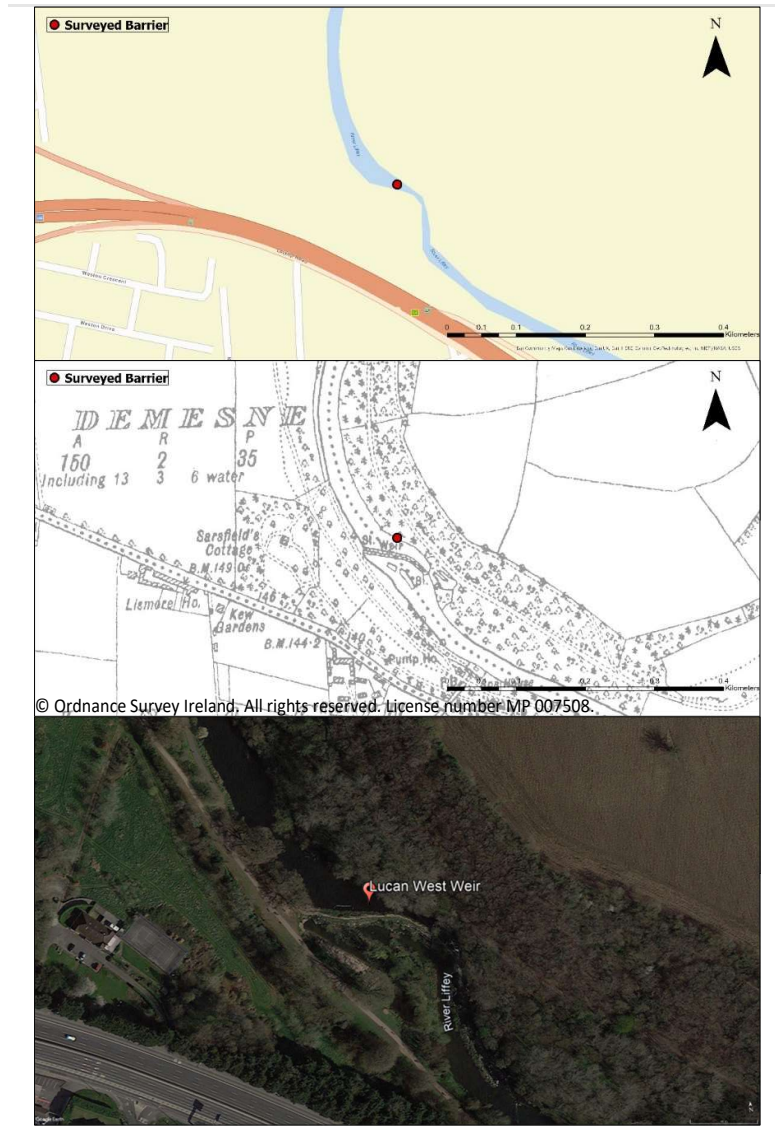
This weir is 1.49km upstream from Lucan Weir, and 12.96km upstream from the tidal limit at Island Bridge. It is located just north of the N4, on the border between the townlands of Lucan Demesne and Coldblow. The structure was built in the late 18th century and is constructed from pre-cast concrete and limestone masonry. The height of structure meant that it was unsafe to gather certain measurements at the site. The width of the barrier along the crest was estimated to be 95m. The width of the channel at this point was an estimated 35m. The sloping weir presented a single transversal, a breached sluice on the north side of the river that is currently used for slalom kayaking or canoeing.

Figure 37. The location of Lucan West Weir on ESRI world street map, historic 6-inch OSI map (1829-41), and Google Earth ortho-imagery (2021).

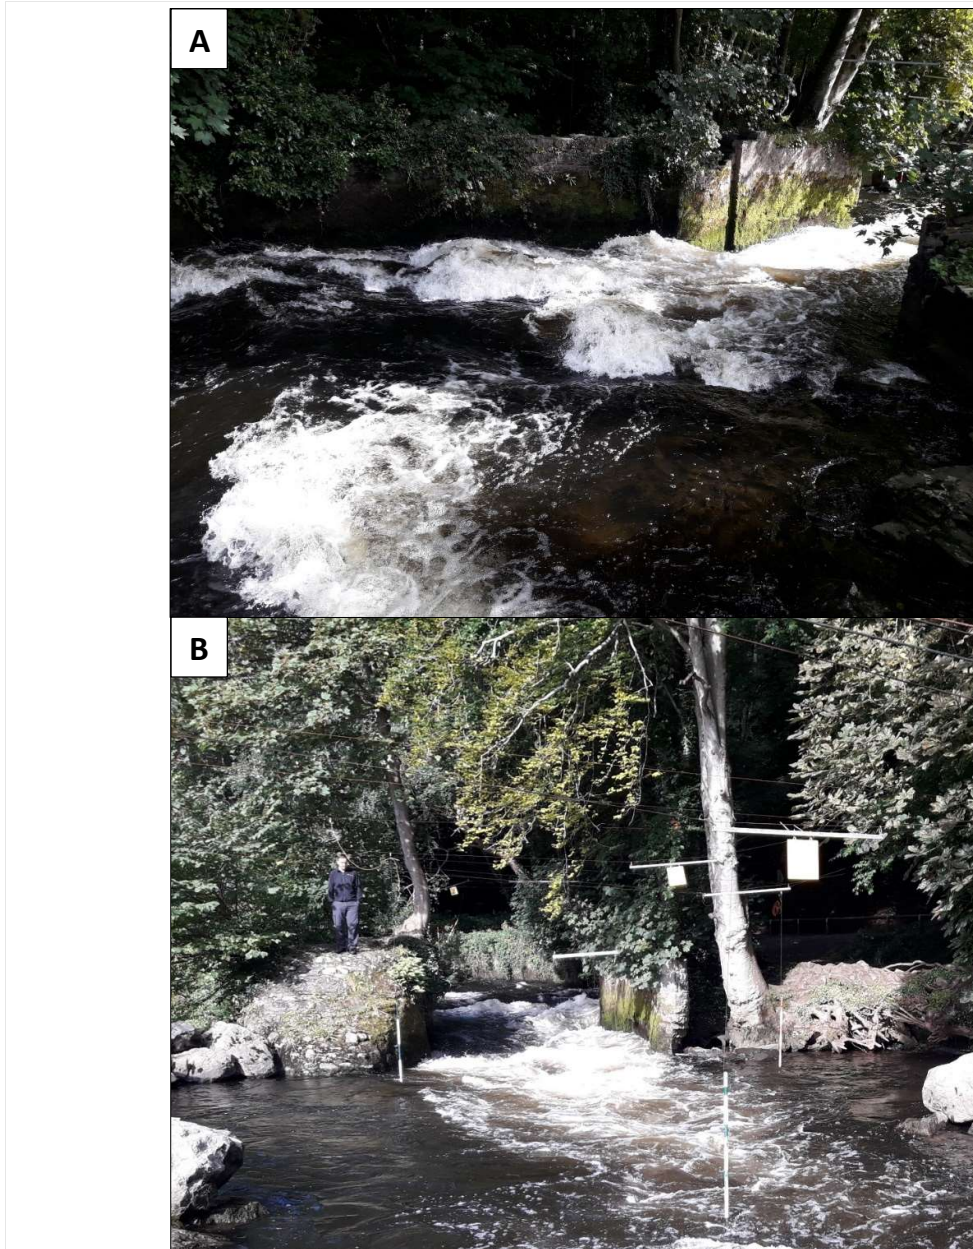
On the day of assessment, this transversal was unsafe to measure. However, the high levels of turbulence rendered the sluice a complete barrier (score 0.0) to upstream migration for cyprinids, adult lamprey, juvenile eel, and juvenile salmonids. The presence of a standing wave, in addition to the high levels of turbulence, created a high impact partial barrier (score 0.3) for adult salmonids. Downstream migrants faced no barrier (score 1.0) from debris or damaging structures, but it was possible that high velocities could cause a swim barrier.

Figure 38. Breached sluice from (A) upstream and (B) downstream (TS1).

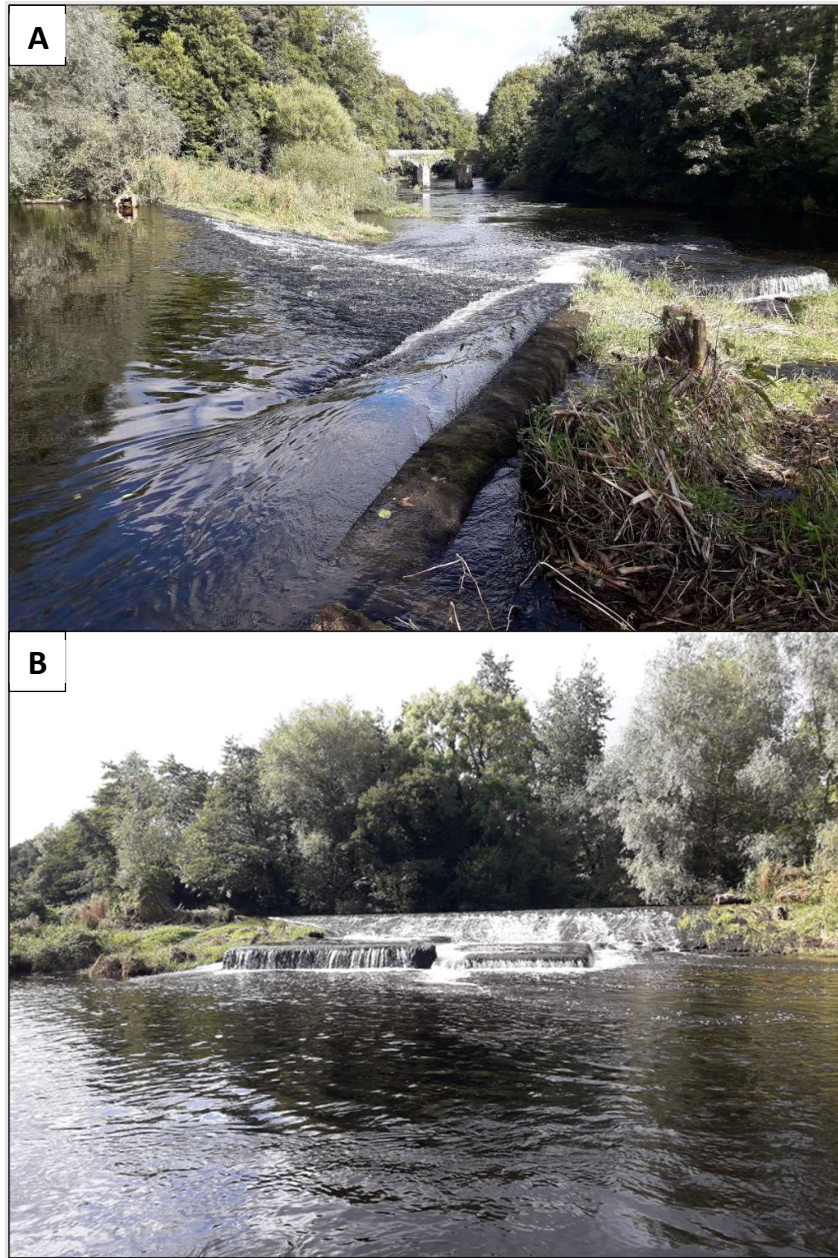
In prevailing conditions, this fish passage option was a complete barrier (score 0.0) to the upstream migration of all species, except juvenile eel. For juvenile eel, the transversal posed no barrier (score 1.0) as a climbing substrate was available. Slope (17.09%) and high midpoint water velocities ($\geq 3\text{m/s}$) resulted in a complete obstacle for all other species. The step height (0.3m) was an additional prohibiting factor for cyprinids and adult lamprey. Downstream migrants encountered no barrier (score 1.0) at this transversal.

Figure 40. Fish passage option (TS1) from (A) upstream and (B) downstream.

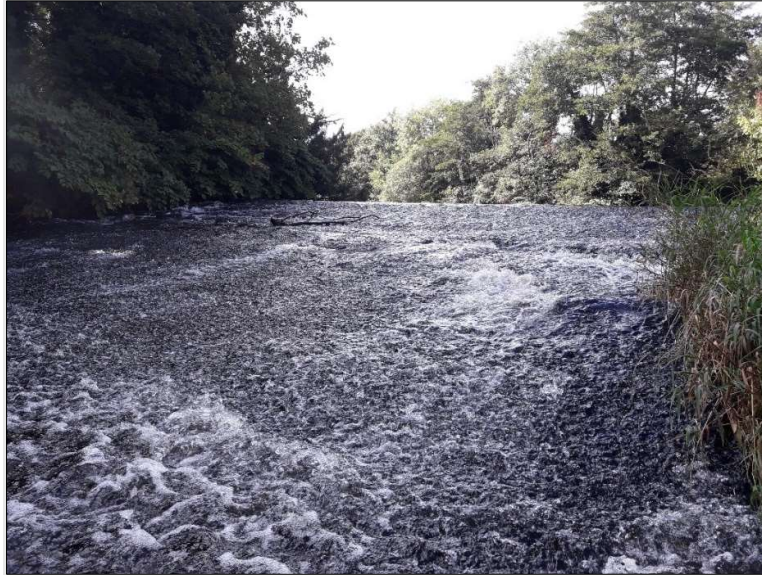
Figure 41. Weir face (TS2).

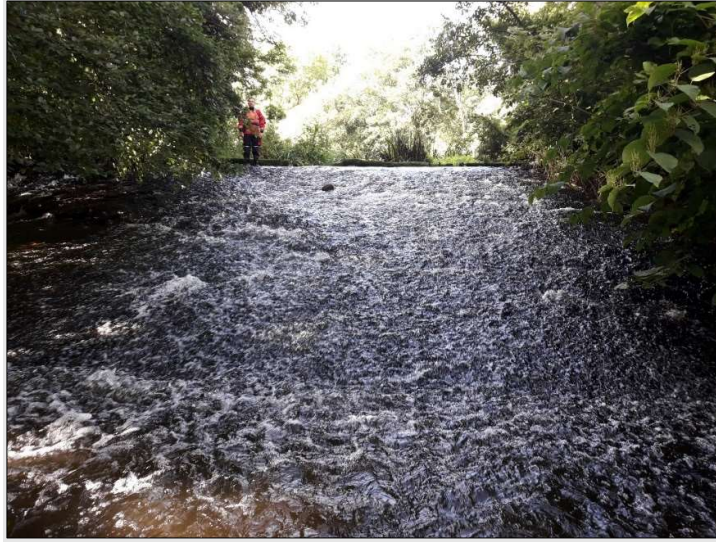
Figure 42. Weir face (TS3).

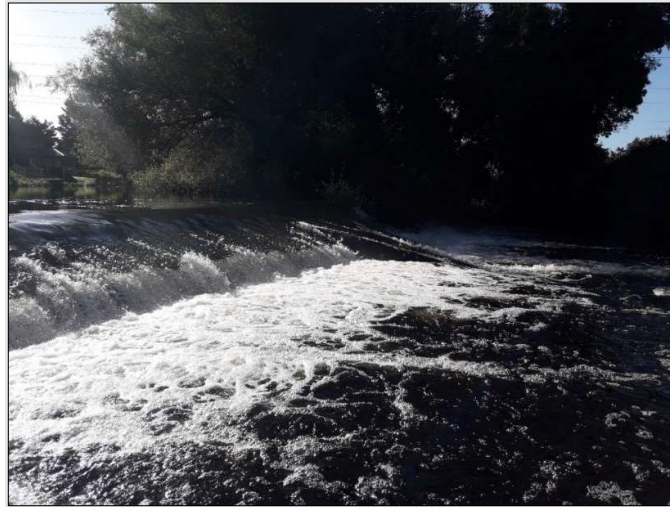
Figure 44. Weir face (TS1).

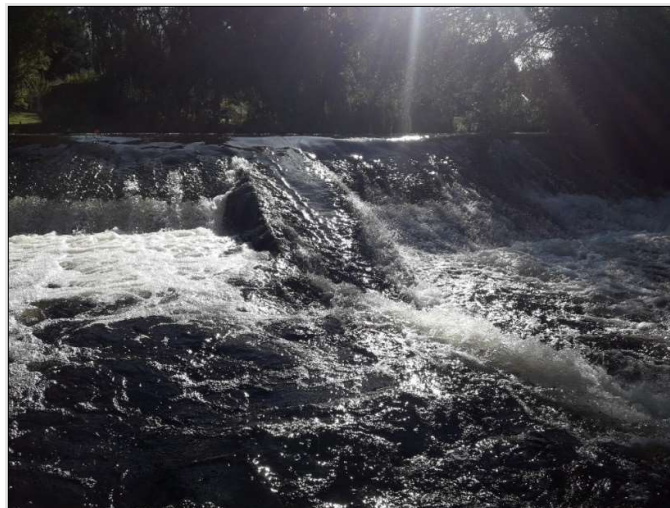
Figure 45. Fish passage option (TS2).

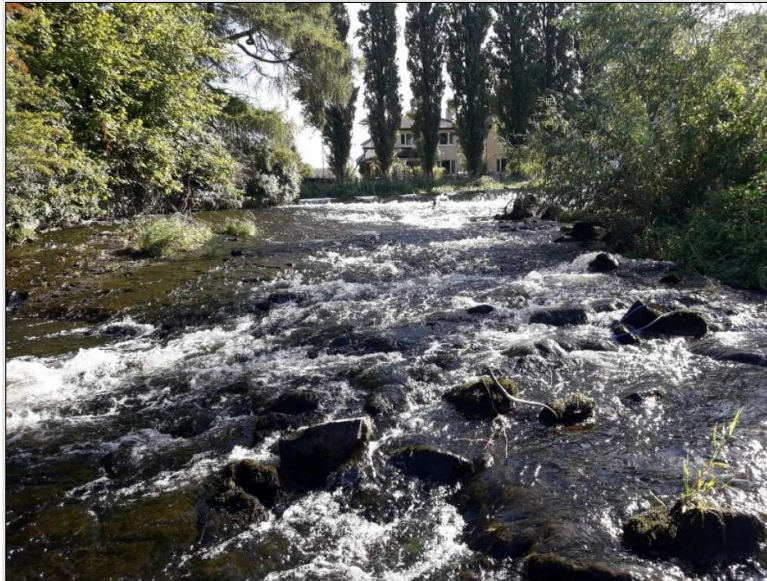
In prevailing conditions, this transversal was a high impact partial barrier (score 0.3) to upstream migration for all species except cyprinids and juvenile eel. For juvenile eel, the transversal posed no

Figure 46. Weir face (TS3).

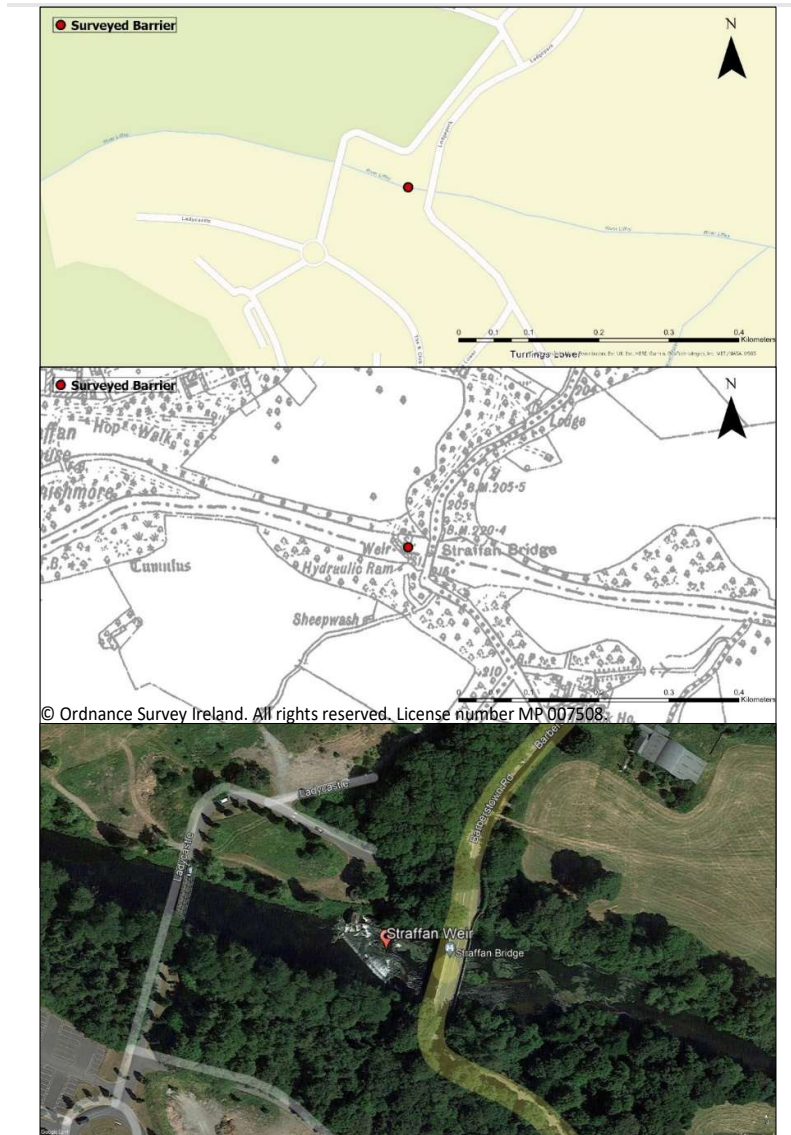
This weir is 8.26km upstream from the previous barrier and 29.33km upstream from the tidal limit at Island Bridge. The barrier is located immediately upstream of Straffan Bridge, Co. Kildare. The current structure was built circa 1930, however a weir at the same location is also visible in the historic OSI maps dating from the early 19th century (Figure 47). The weir is of masonry construction with a total hydraulic head height of 2.28m. The estimated width of the barrier along the crest is 50m, all of which were wetted on the date of survey. The estimated channel width at this point is 30m. The weir offered three transversal sections which are detailed below.

Figure 47. The location of Straffan Weir on ESRI world street map, historic 6-inch OSI map (1829-41), and Google Earth ortho-imagery (2018).
