River Liffey WFD III Barrier Assessment Obstacles to Fish Passage and Mitigation Options

IFI/2023/1-4635

Citation: Donovan, R., Coghlan, B., O’Brian, R., & O’Leary, C., (2022). River Liffey WFD 111 Barrier Assessment – Obstacles to Fish Passage and Mitigation Options. National Barriers Programme. Inland Fisheries Ireland. Citywest, Dublin.

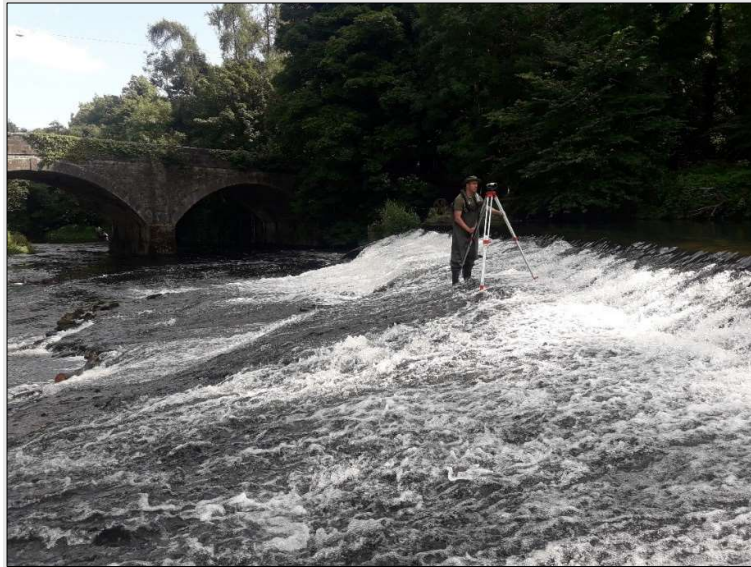
Figure 48. Weir face (TS1).

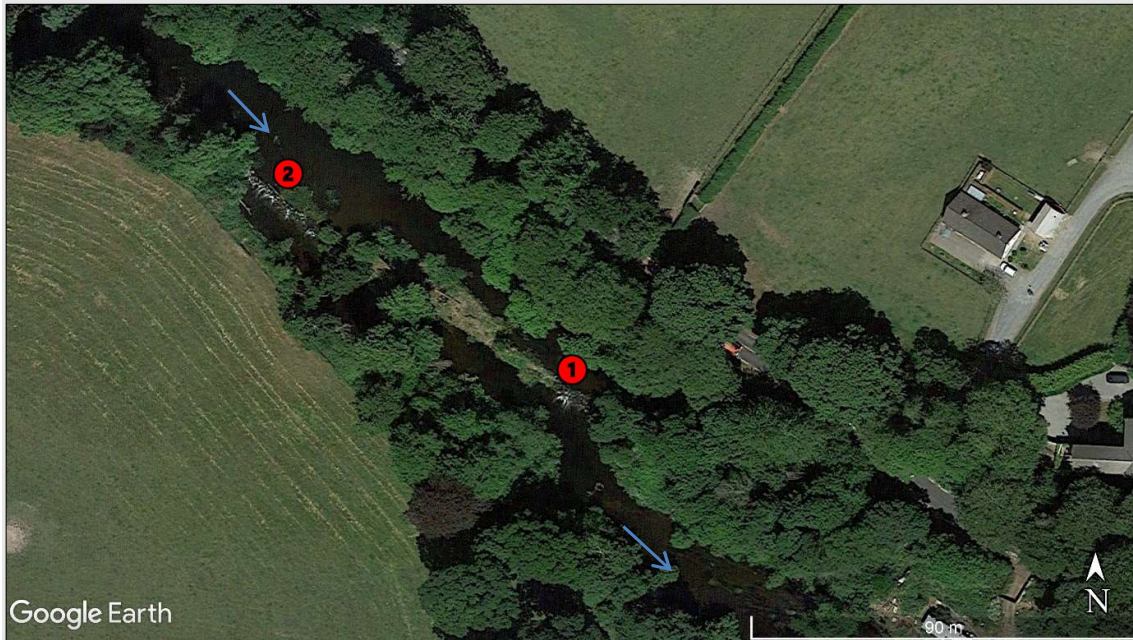
Figure 55. Google Earth ortho-image of Morristown Weir, June 2018. Blue arrows denote flow direction and red circles indicate transversal section number.

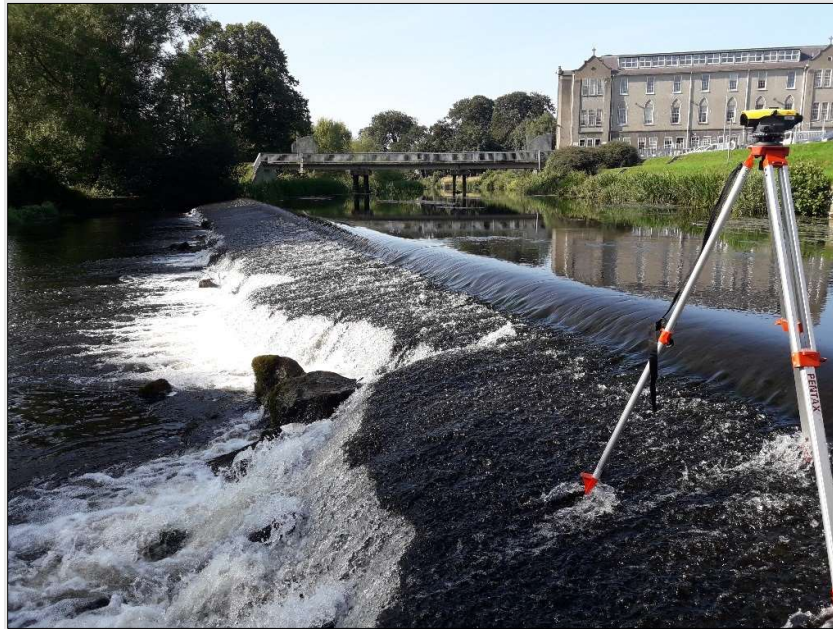
Figure 57. Weir face (TS1).

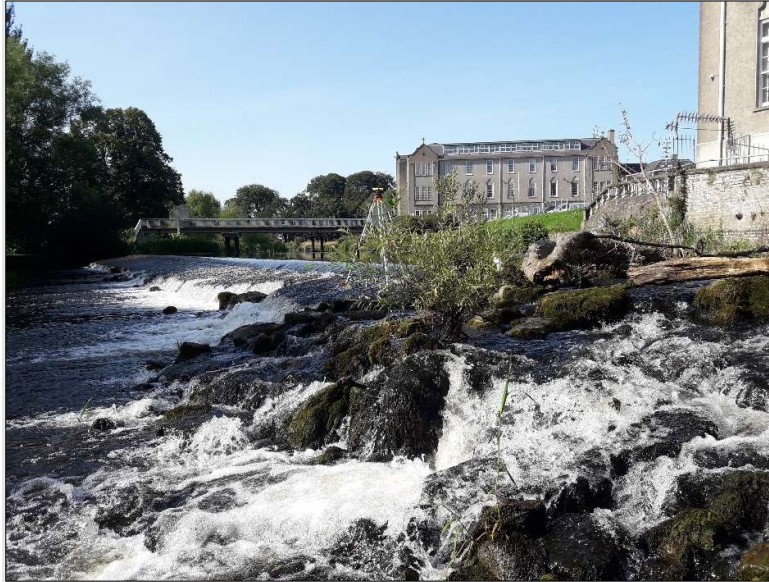
Figure 58. Broken section of weir (TS2).

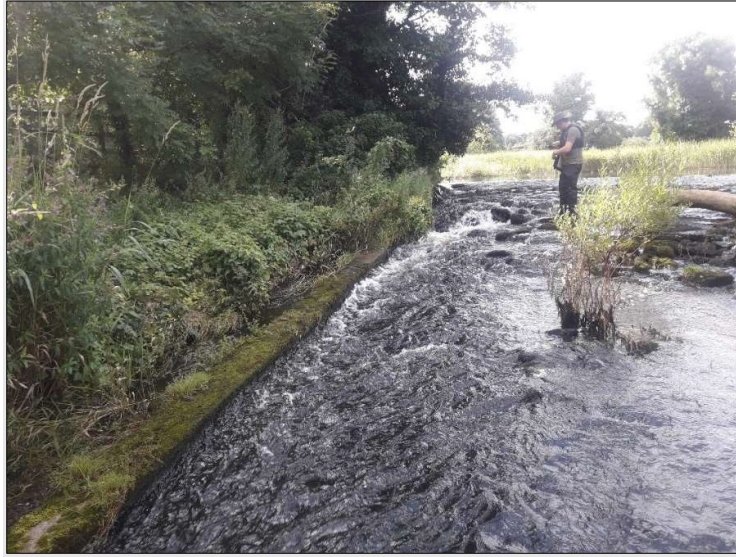
Figure 61. Fish passage option (TS1).

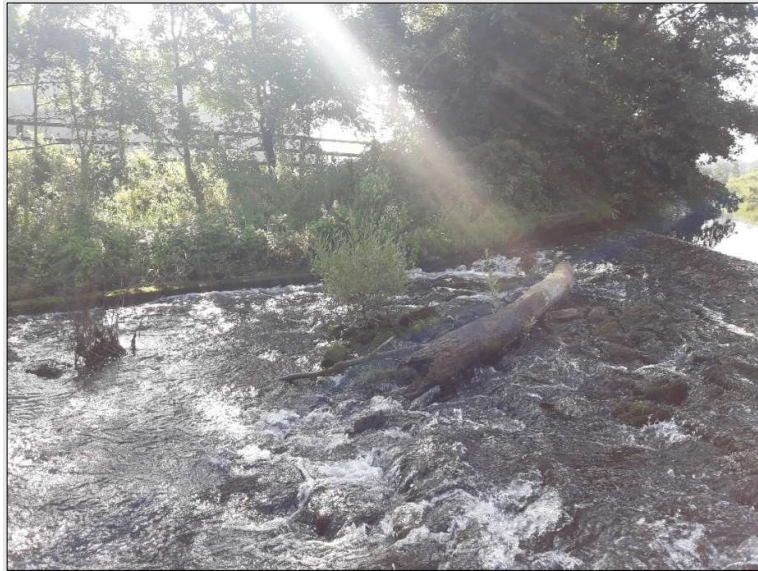
Figure 62. Weir face (TS2).

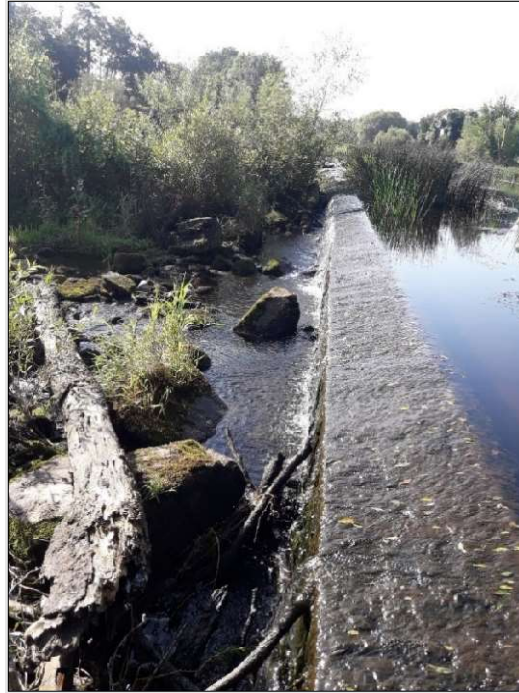
Figure 63. Vertical drop (TS3).

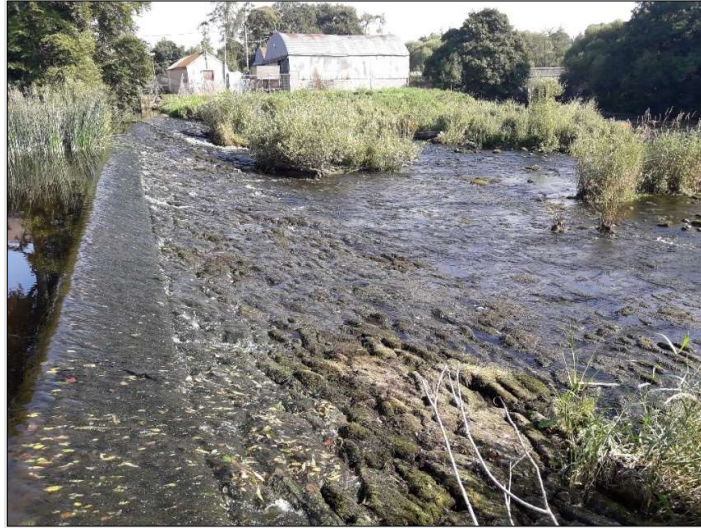
Figure 64. Weir face (TS4).

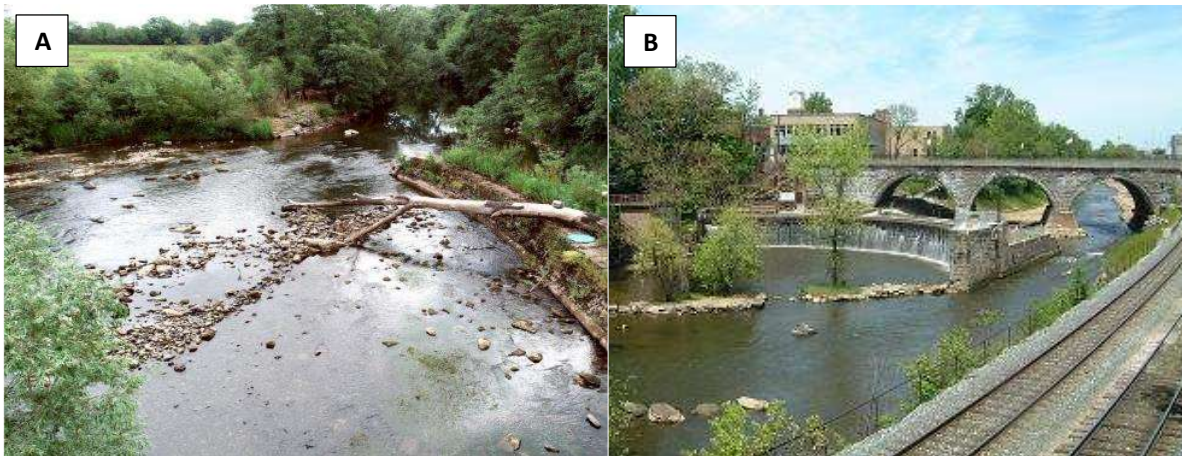
Figure 66. Photos of breached weirs: (A) Ballyclough Weir in the Mulkear River, Co. Limerick, and (B) Kent Dam in the Cuyahoga River, Ohio, USA (breach in far right of image).

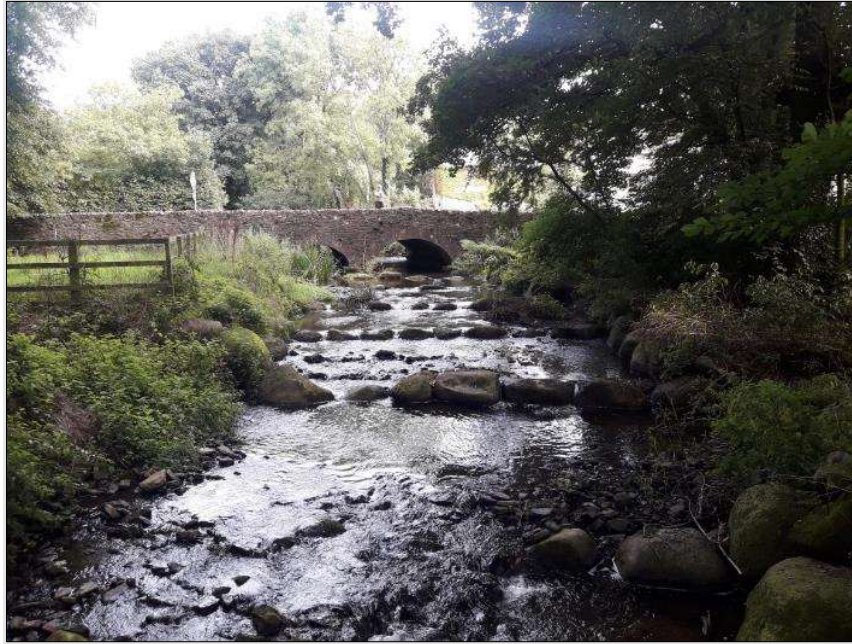
Figure 69. A full width pool and boulder rock ramp type fishway at Tuckmill Bridge, River Slaney, designed to mitigate the barrier impact of a bridge apron/culvert.

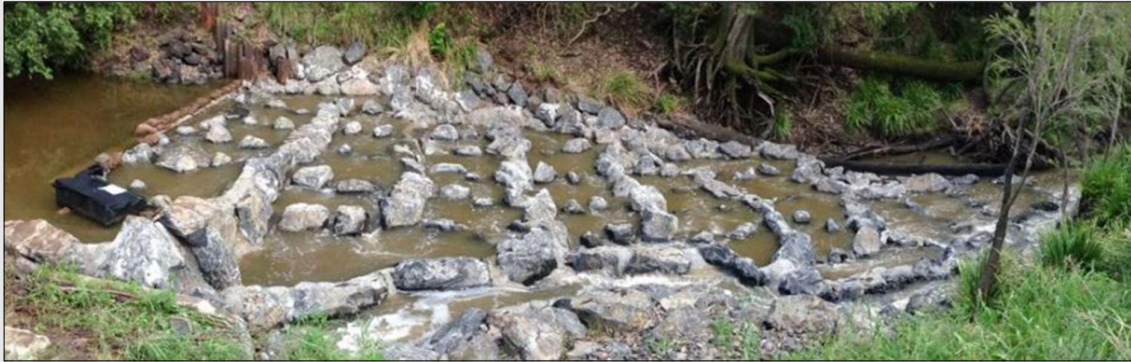
Figure 70. A full-width pool and boulder rock ramp fish pass designed to mitigate the impact of a weir on fish passage <https://catchmentsolutions.com.au/portfolio/rock-ramp-fishway/>

hydromorphological surveys to assess feasibility. Bypass channels may be a viable alternative in some cases but opportunities for their construction will be limited in urbanised environments, due to a lack of lateral space. The last option is mitigation via the installation of a fish pass. In this event, the preference is for the construction of a gently sloping pool and boulder rock ramp (Figure 70).
