3. Restoration: Stonyford River, Boyne catchment

Long-term river restoration project

A study site was set up on the River Stonyford in 2013. The rehabilitation strategy was to fence the channel, excluding livestock, and eliminating channel maintenance. The type of routine maintenance which had previously been undertaken by the OPW at this site included vegetation removal and silt management.

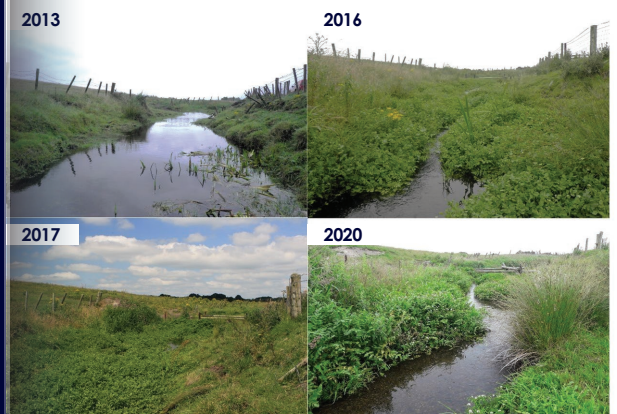
Survey site pre-livestock exclusion and halting of maintenance works (2013), three years post-works (2016), four years post-works (2017) and seven years post-works (2020).

Substrate:

- Reduced fine sediment and increasing substrate coarseness over time
- More variety for juvenile fish to inhabit and more potential spawning areas

Macrophytes:

- Lack of plant diversity initially
- Pioneer macrophytes established
- Lag period where instream plants filled the channel space, impeding flow
- More recent surveys indicate reduction in plant cover as the channel adjusts to more natural conditions
- The river channel is now self-cleansing, reducing the level of active maintenance required

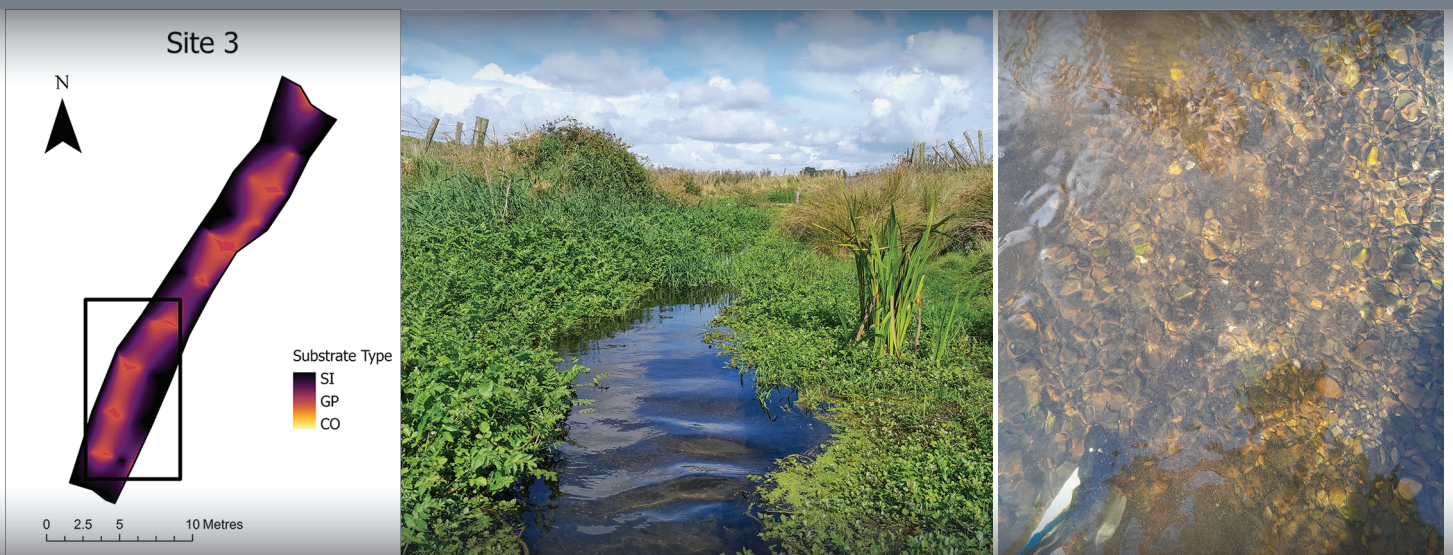
On site photos taken of experimental site 3 in September 2022 of spawning gravels available giving context to the plot generated displaying substrate condition. (CO – cobble; GP – gravel/pebble; SI – silt).

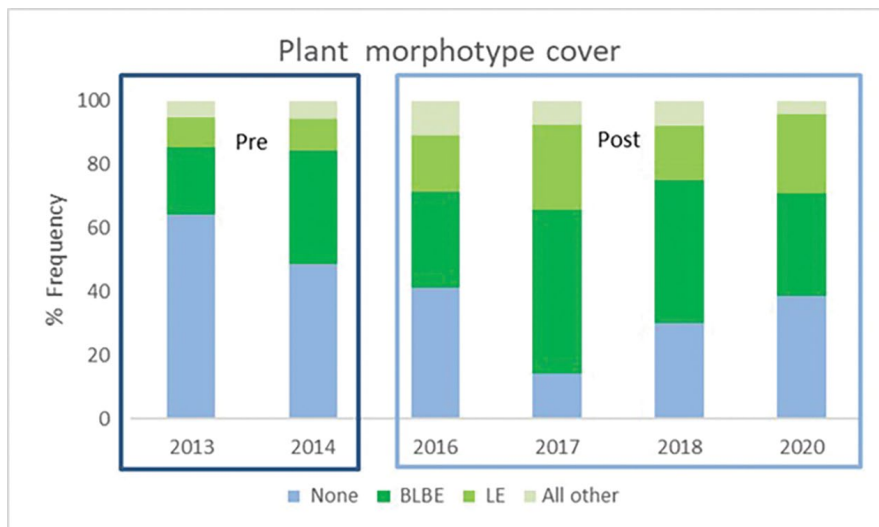
Proportion of linear emergent (e.g. reed canary grass and burr reed) increased at the stabilised channel margins whereas the proportion of branched broad leaved emergent (e.g. water cress and foals water cress) has reduced by the end of this survey period.

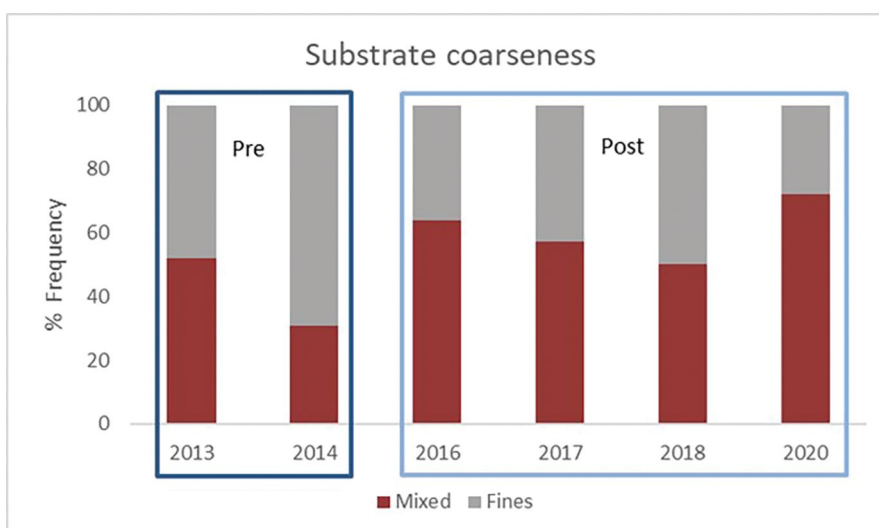
Fine silts have reduced from 50-70% in pre-survey period when maintenance was routinely occurring, to approximately 30% of total substrate in 2020.
