# A novel approach to aquatic weed control and habitat restoration using biodegradable jute matting

Article in *Aquatic Invasions* · April 2011

This technical paper presents results from pilot field trials conducted on the novel use of a biodegradable jute material to eradicate the highly invasive aquatic macrophyte *Lagarosiphon major* Ridley from Lough Corrib, Ireland. The results demonstrate the ability of the jute material to comprehensively kill *L. major* and to restore native macrophyte communities to areas of the lake that were previously overgrown with this priority invasive species. To date, eight indigenous plant species (four charophytes and four angiosperms) have been recorded growing through the loose-weave jute fabric. However, no *Lagarosiphon* has been recorded as doing so. This material has the potential for broader application in the management of nuisance aquatic weeds and in the restoration of native flora extirpated by these alien species.

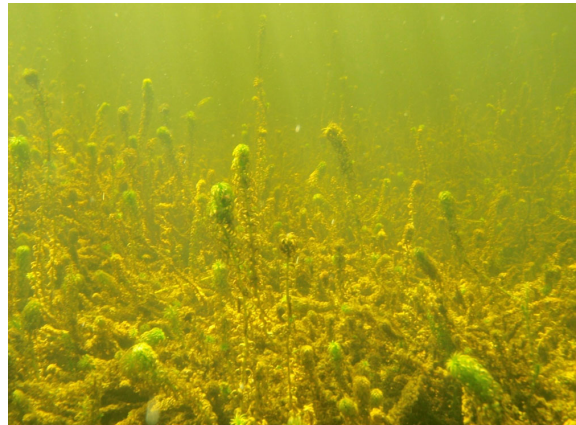
**Figure 2.** Typical *Lagarosiphon major*-dominated habitat prior to jute application (photograph by Joe Caffrey).

Seven *L. major* dominated sites were treated with jute matting between August 2008 and October 2009 (Figures 1, 2 and Table 1). The areas of lake bed covered varied between 100 and 5000 m<sup>2</sup>. The length of time the jute matting was in place ranged from 4 to 17 months. Before placing the jute matting the extent of the infestation with *L. major* at each sampling location was recorded as follows: total cover = 1 (where the plant occupied *circa* 100% and no other macrophyte species were present) and extensive dense patches = 2 (where *L. major* was the dominant plant but small stands of native species or areas of exposed lake bed were present). At the end of the trial period a series of measurements were recorded at each site. These included: a) status of *L. major* having been covered for a specific duration (live and intact = 1, decaying = 2, fully decomposed = 3); b) condition of jute matting (intact = 1, intact but easily torn = 2, intact but disintegrates on contact = 3); c) extent of sedimentation on jute matting (none = 1, partially covered = 2, jute not visible

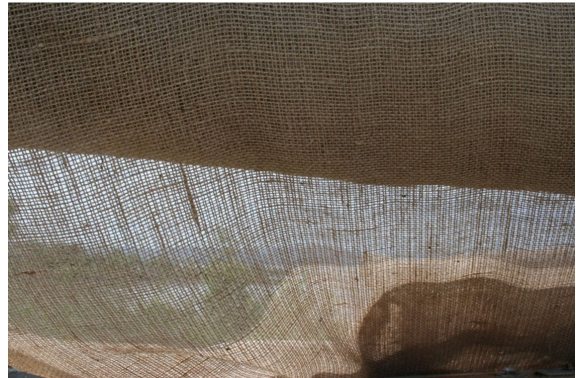
**Figure 3.** A view through the open-weave jute matting used to kill *Lagarosiphon major* in Lough Corrib (photograph by Joe Caffrey).

A natural and biodegradable material was sought to replace plastic or polyethylene sheeting commonly used for light exclusion in aquatic weed control programmes. Rolls of jute matting (5 m wide × 900 m long, *circa* 200 gm<sup>-2</sup>) were sourced and trialled on *L. major* in Lough Corrib. Jute is a natural vegetable fibre and the matting used is loose-woven (Figure 3) and durable. Another beneficial characteristic of the product for application in large lake situations is the fact that it saturates on contact with water and rapidly sinks, thus limiting the impact that wind can have on its accurate placement.

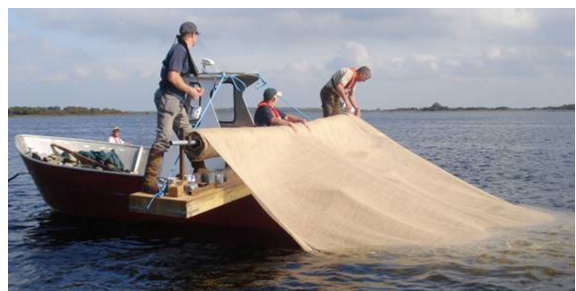
**Figure 4.** Jute matting application using a purpose modified boat (photograph by Joe Caffrey).

Depending on the size of the area to be treated, two methods for applying the jute matting have been developed. Where *L. major* occupies an area in excess of 200 m<sup>2</sup>, a purpose-modified boat is utilised. The matting is deployed from a boat-mounted dispenser directly onto the water surface (Figure 4). The site to be treated is demarcated by divers using buoys. An estimate of the area to be treated is made and sufficient material to complete the operation is

prepared onshore. The jute is commonly laid in 100 m-long strips. Divers are present in the water to oversee the accurate placement of the material and to ensure that strips overlap properly, where this is required. Small weights are attached along each side of the matting, at roughly 5 m intervals, as the material is being laid on the water. This aids in its proper placement on the target weed bed. The matting is secured on the lake bed by the divers using additional weights or pins (Figure 5). Alternatively, where smaller beds of *L. major* (< 200 m<sup>2</sup>) are the primary target, pre-cut sheets of the jute (each ≤ 5 m × 15 m) are manually laid over the target weed bed from a boat or are brought into position by divers from the shore. As before, the material is secured in place by divers.

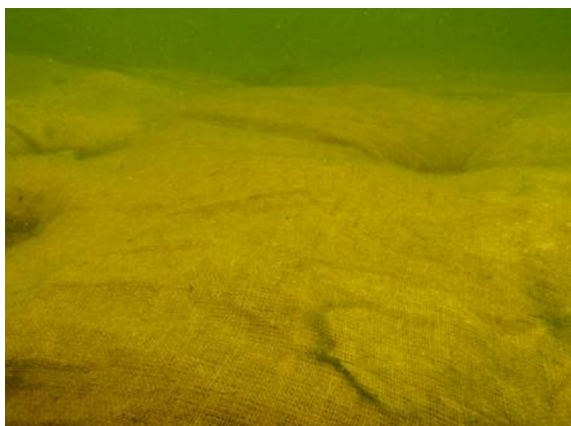
**Figure 5.** Jute matting secured *in situ* on the lake bed (photograph by Joe Caffrey).

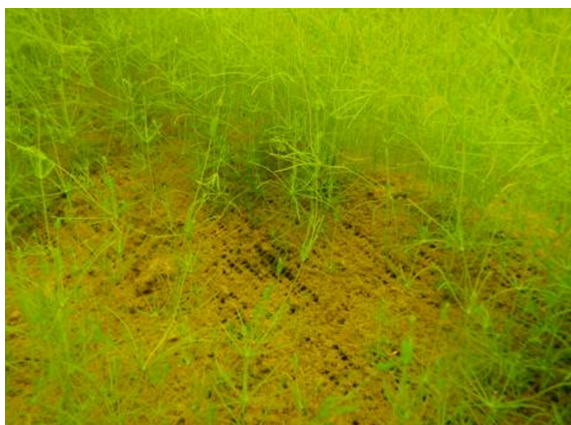
**Figure 6.** *Nitella flexilis* growth on the jute matting 8 months after application at site Ard Point (photograph by Joe Caffrey).

communities. Within seven months of placing the matting over dense *L. major* beds, relatively dense beds of native macrophyte species were observed growing through the material (Figure 6). Moreover, the presence of *C. virgata* at Gortdrishagh Bay and *N. flexilis* at Kid Island suggests that this regeneration process can commence in as short a time period as four to five months after the matting is applied. The emergence of *C. rudis* through the matting, at Kilbeg South, was somewhat unexpected as this is one of the physically larger charophyte species present in the lake. It was thought that its large size might preclude it from growing through the weave in the matting.
